Annex A: Reports of all project stays of project members

OeAD KOEF Project
*“Investigating the Roman hydraulic complex between
Zaghouan and Carthage (Tunisia).”*

STAY R e p o r t s

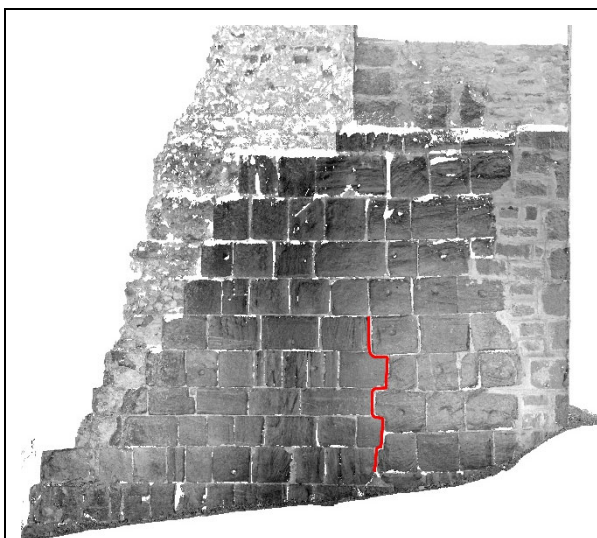
East of the four southern-most pillars (P1, P2, P3 and P4) supporting walls in different state of conservation are preserved. The northern-most supporting wall (P4) is detached of the medieval pillar (rammed earth structure) while the remaining three pillars are still interlocked with the Roman supporting walls. Supported by several references, it can be stated that the aqueduct was built without the supporting walls. However, the building material and construction techniques show that the supporting walls were added during antiquity.

Fig. 4: P2-N, shifted horizontal joints with collision of masonry of pillar and supporting wall

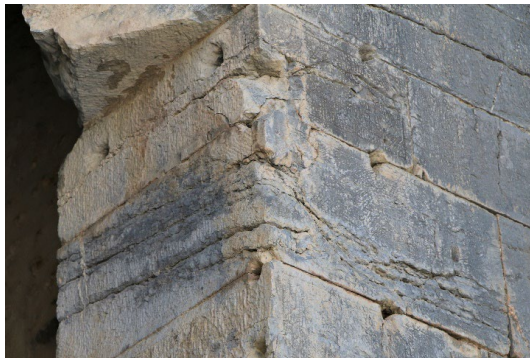
Fig. 26: Cracks, ashlar masonry, cella entrance, Water Temple

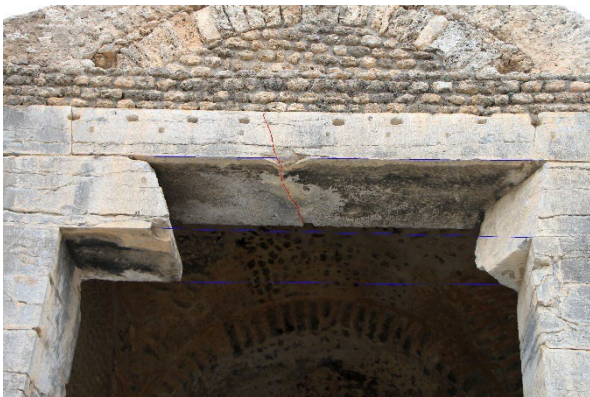
Fig. 27: Vertical crack, architrave / door lintel, Water Temple

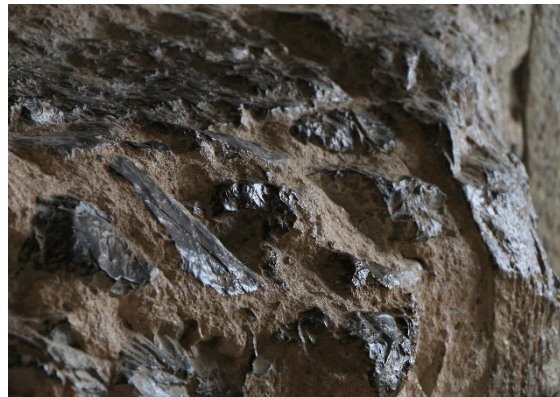
Fig. 28: Glossy aspect, cella interior, Water Temple

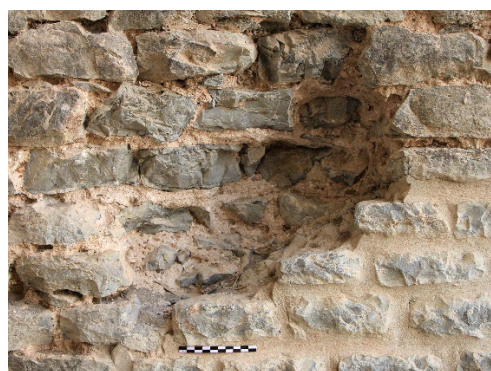
Fig. 30: Missing masonry, rubble wall, exterior cella, Water Temple

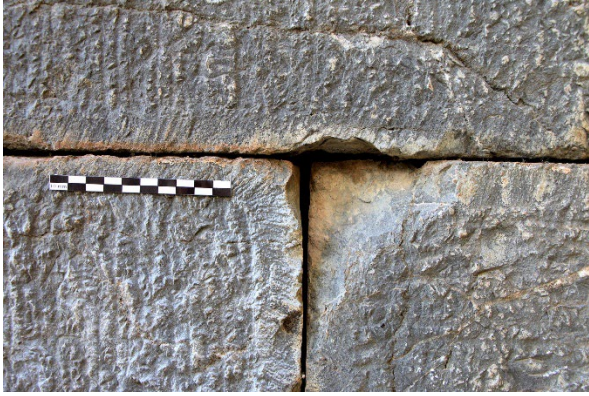
Fig. 31: Missing joint mortar, ashlar masonry, Water Temple

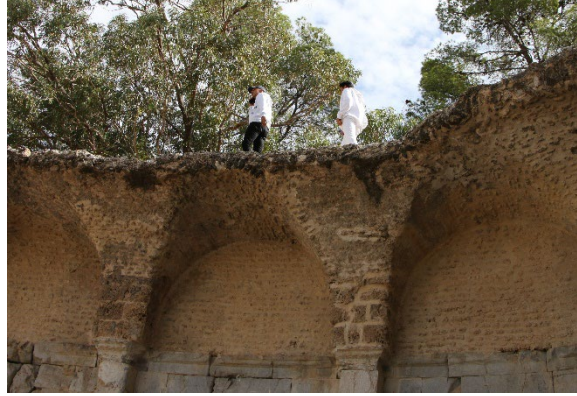
Fig. 32: Visitors walk on vault zone, Water Temple

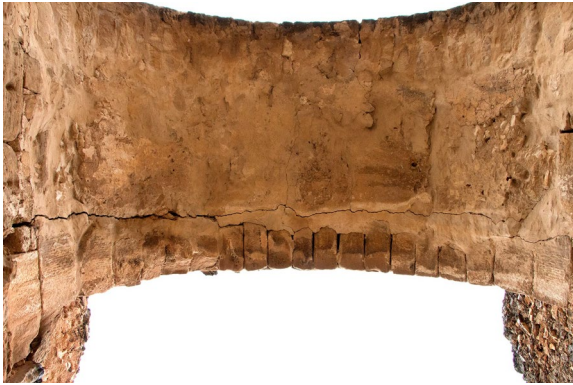
Fig. 51: Cracks between sandstone arch stones and rubble vault, Aqueduct
Fig. 52: Biological Colonization arch and specus zone, plants as well as black biofilm and lichens, Aqueduct

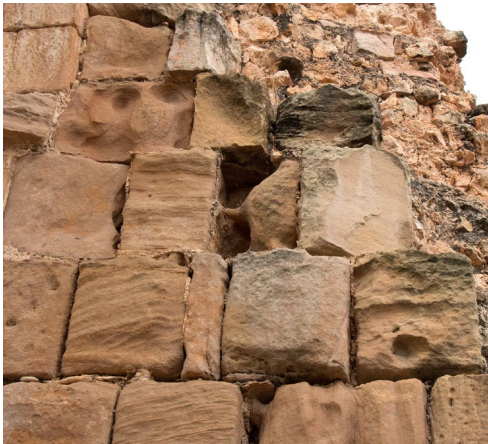
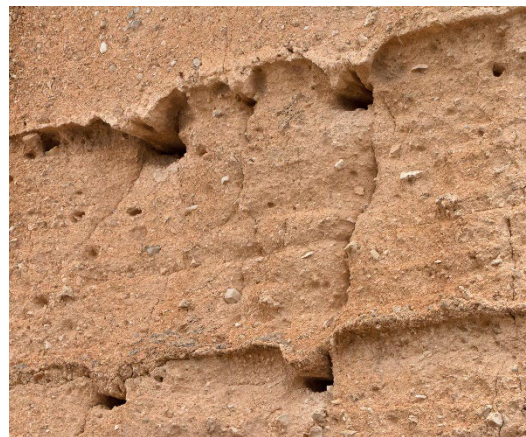
Fig. 53: Missing surface due to erosion of sand stone ashlar blocks, Aqueduct
Fig. 54: Missing surface due to erosion of rammed-earth matrix, Aqueduct

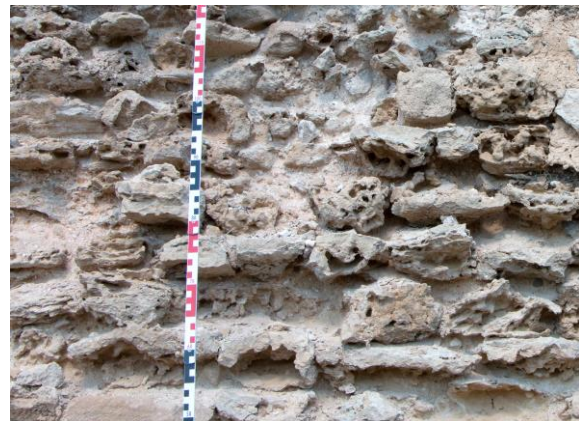
Fig. 16: damages roman masonry

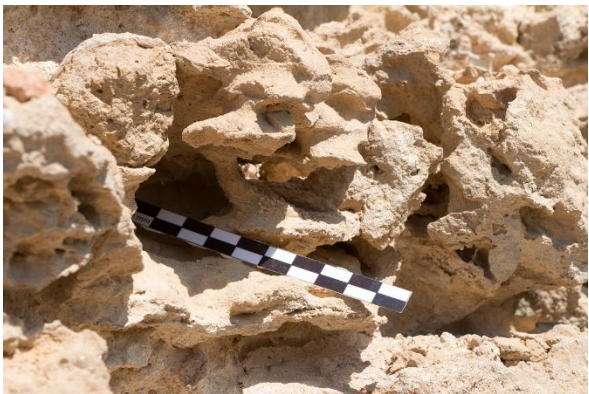
Fig. 16a: damages roman masonry, detail alveolisation masonry stone

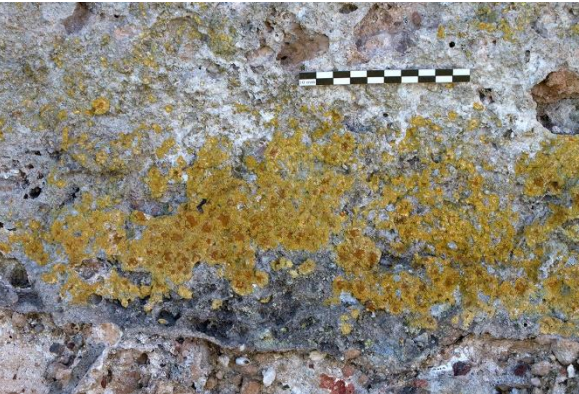
Fig. 17: lichens

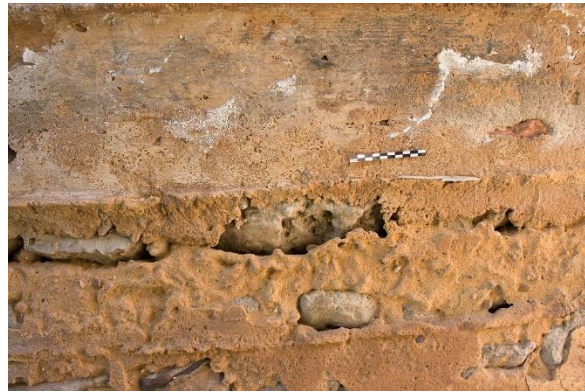
Fig. 19: salt efflorescence and damaged mortar

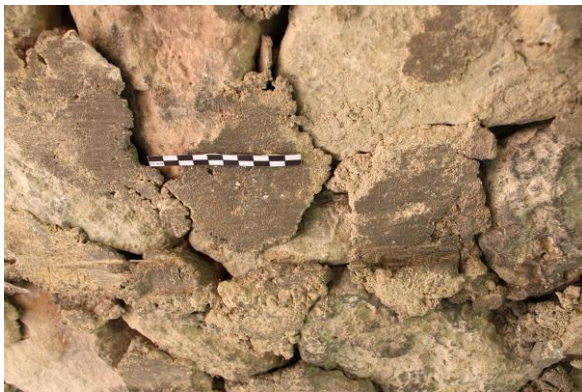
Fig. 20: black deposit / crust underside vault

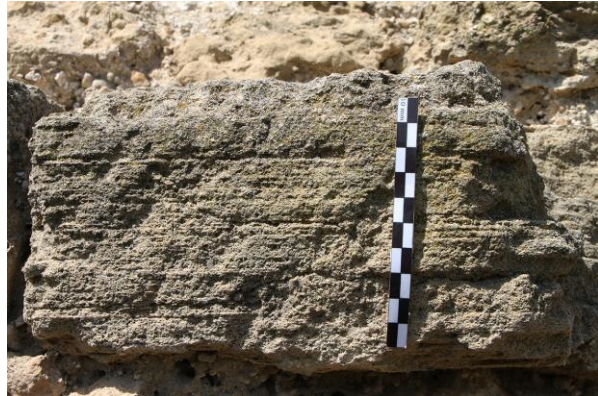
Fig. 21: delamination of sand-limestone

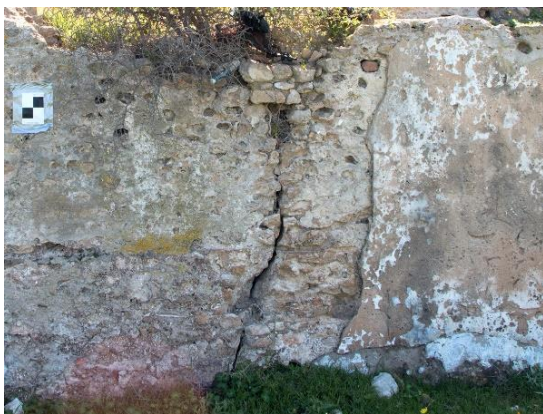
Fig. 22: vertical crack north side

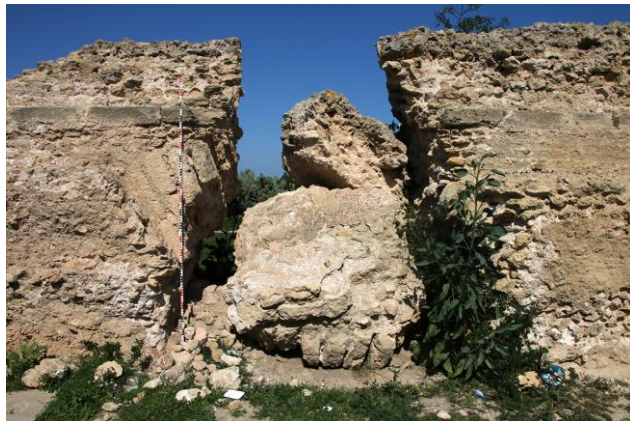
Fig. 23: collapsed arch, aqueduct

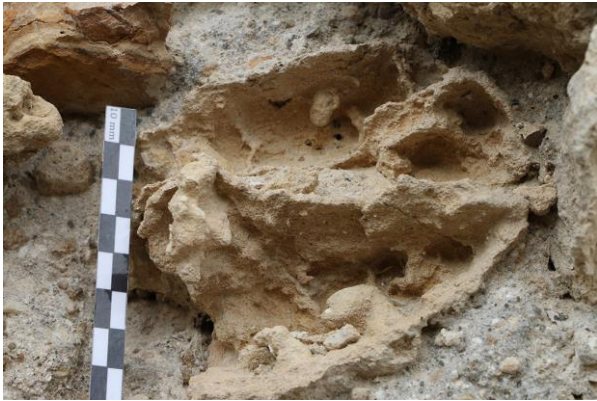
Fig. 34: sanding and alveolization masonry stone arch, cisterns

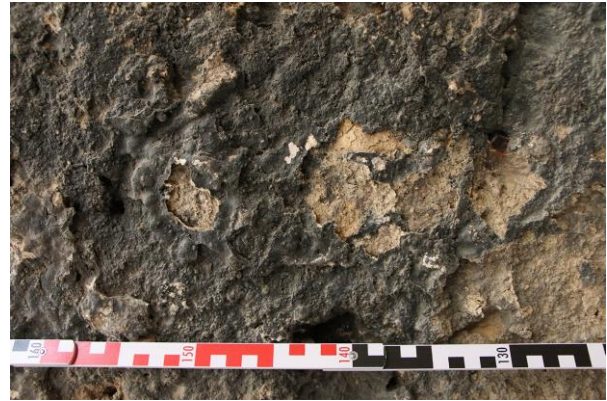
Fig. 35: black crusts, vault interior, cisterns

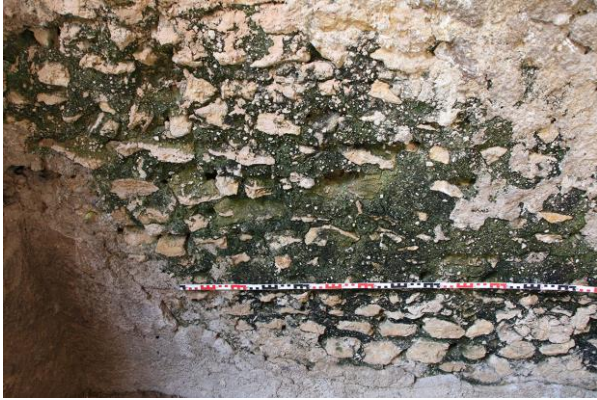
Fig. 36: biological colonization interior vault, cisterns

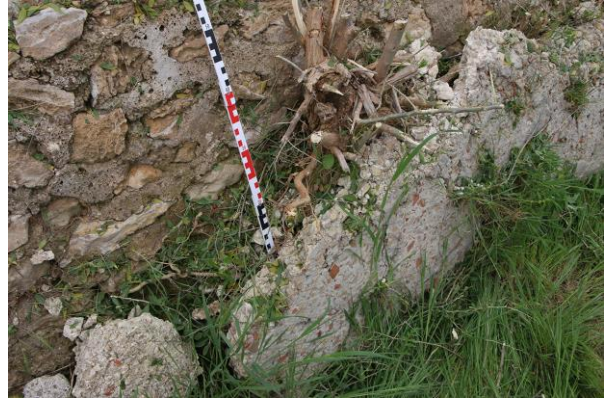
Fig. 37: plants exterior drain channel, cisterns
