Annex A: Reports of all project stays of project members

OeAD KOEF Project
*“Investigating the Roman hydraulic complex between
Zaghouan and Carthage (Tunisia).”*

STAY R e p o r t s

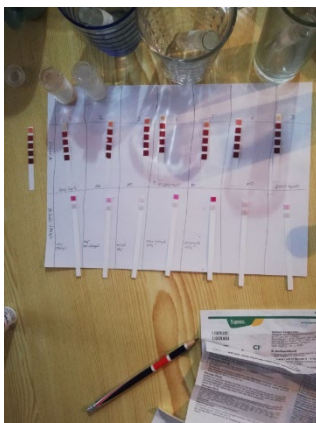
Fig. 3: Nitrate and chloride tests were carried out on damaged stone samples.

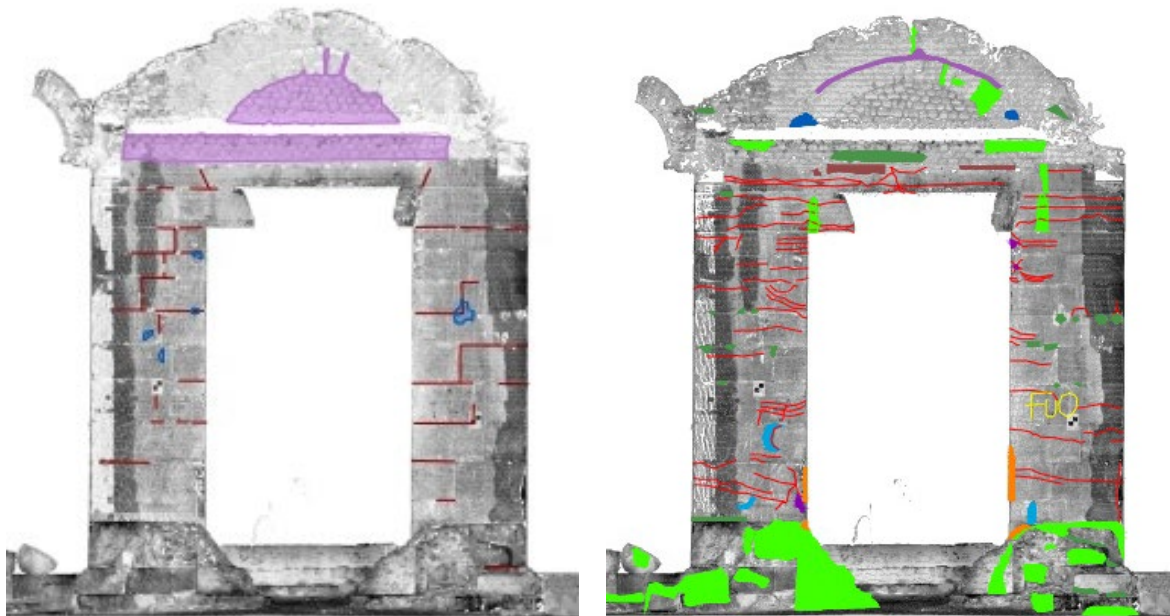
Fig. 5: Cella of the Spring sanctuary in Zaghouan, view of the facade: Inventory and condition mapping

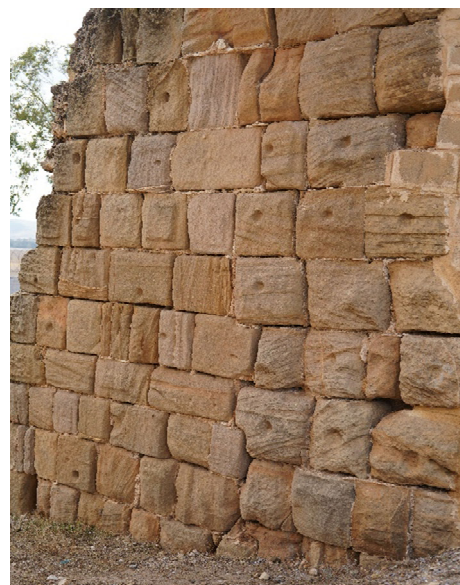
Fig. 5: marks of lifting tool ("Zangenlöcher")

The most striking clue is that the opus caementicium covers the stones of the arches. Another clue are the horizontal joints of the supporting walls which lay on a different height than the horizontal joints of the pillars. To allow the stones of the pillar and supporting wall to interlock, the corner stones of the pillars were removed, and edges were partly worked out on the stones of the pillar. The marks of a lifting tool (“Zangenlöcher”) in the stones of the pillar and the supporting walls give another hint for secondary construction

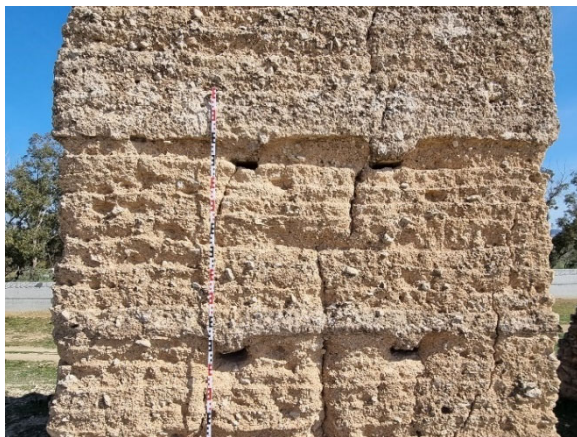
Nine of the altogether 12 pillars are built in pisé and have a distinctive external appearance. Pinkish layers of a height of about $85\text{cm} \pm 5\text{cm}$ alternate with white highly chalky levelling layers of about 5cm to 10cm. Due to the necessary height of the impost for the vault the upper most layer of pisé varies in height. It can be assumed that the beam holes (width ~ 10 to $\sim 15\text{cm}$, height ~ 5 to 8cm , depth ~ 65 to $\sim 80\text{cm}$) below the levelling layers are remains of the formwork used to make the pisé pillars.

Fig. 6: Pillar 4 west face, rammed earth with levelling layers

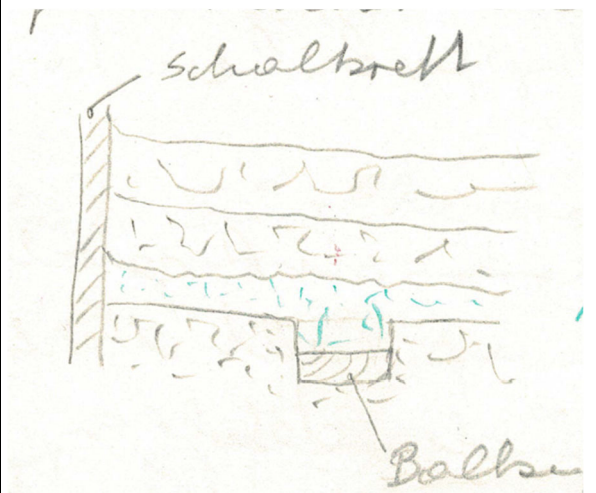
Fig. 7: cross section through pisé pillar with formwork and beam

Each pinkish earth layer consists of 9 to 10 courses. Each of these courses was poured individually and compacted to an average height from 8cm to 10cm. The bottom course was applied damp on top of the levelling layer, which was also still damp. This is indicated by the good connection between the top of the levelling layer and the lowest course of rammed earth. On the other hand, it can be seen on the lower edge of the levelling layer that there is no connection between the rammed earth and the levelling layer. Rather, a clear separation is visible at the lower edge of the levelling layer and an edge is created. This could be the result of pouring the levelling layer on the almost completely dry last course of rammed earth. At the corners of the pillars, the levelling layer and the individual courses of the pisé rise somewhat, which can be attributed to the difficulties of compaction in the corners of the formwork.

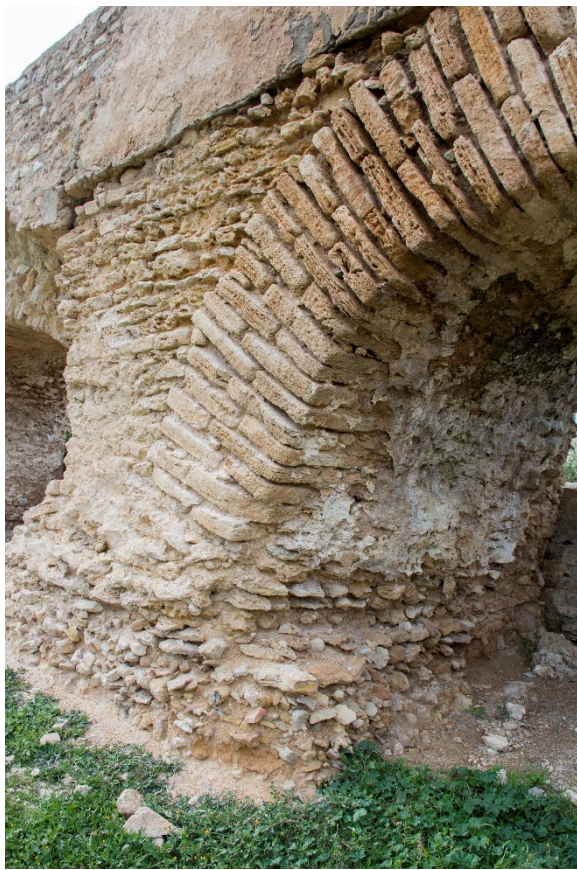
Fig. 4: aqueduct, preserved antique vault between pillar P8-P9 in the foreground and robbed vault in the background

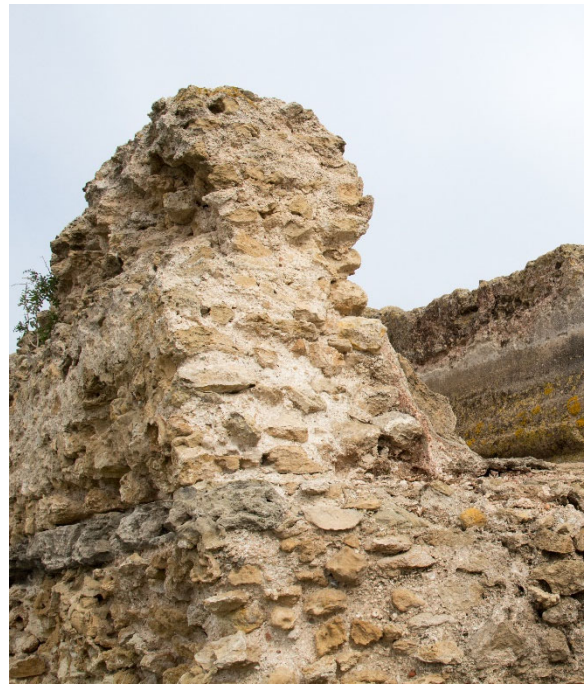
At the upper edge, below the sole of the specus a layer of grey stones is visible at the façade and serves as a levelling layer. However, this levelling layer does not extend through the entire aqueduct but can only be observed on the two facades. The channel of the specus is preserved over almost the entire length of the selected segment. In the North, in the curve of the aqueduct towards northwest, both walls and the barrel vault of the specus are preserved for a short distance.

Fig. 5: aqueduct, row of grey stones below the sole of the specus

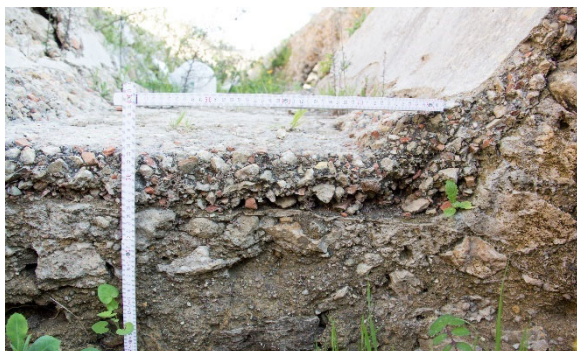
Fig. 6: cistern, drain channel between compartments between 8 and 9, structure and thickness of different plaster layers

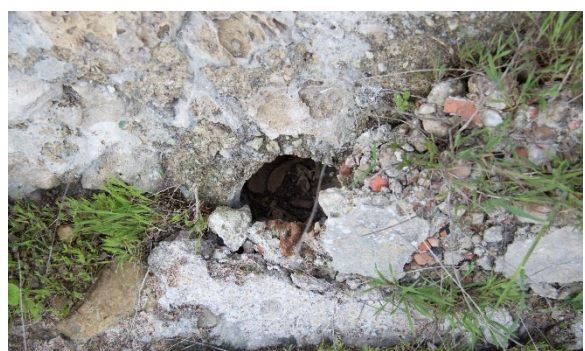
Fig. 7: cistern, drain channel between compartments 9 and 10 southern preserved section, on the vault of comp. 9; clay pipe is covered by opus signinum

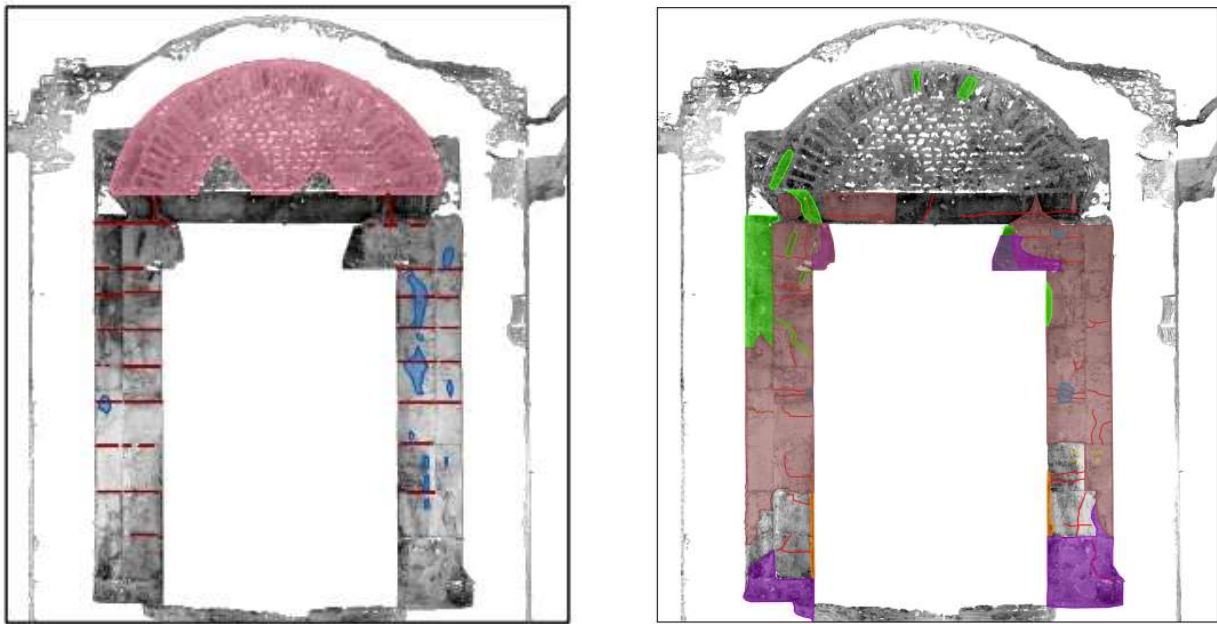
Fig. 3: Digitization of the inventory and condition mapping carried out on the Cella of the spring sanctuary in Zaghouan (interior view of the wall with entrance)

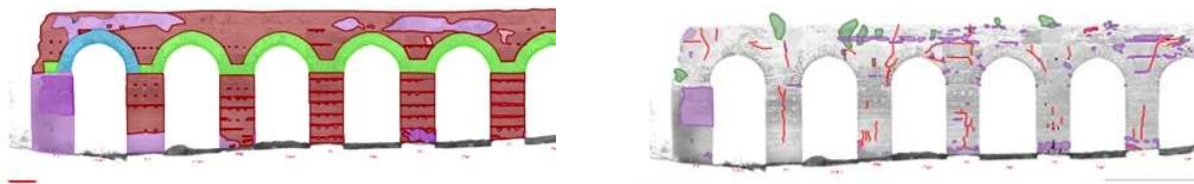
Fig. 4: Digitization of the inventory and condition mapping carried out on the aqueduct section in the Miliane valley

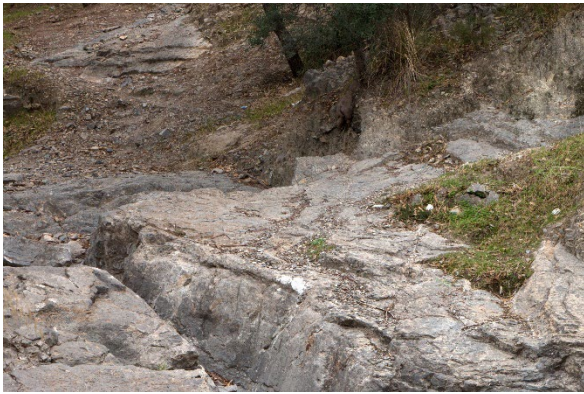
The appearance of the temple is determined by the large-sized ashlar masonry made of gray (-blue) limestone. This stone was extracted from directly neighbouring rocks of the mountain (Fig. 1 and 2). The material was used for the rising masonry, from the ground level up to the height of the capitals. The building material was employed for vertical sections, but not for vaults. The stone is dense and shows no macro-porosity. It has several inclusions, which do not follow a layering and show themselves in white and orange-red lines (Fig. 3 and 4). The chemical composition of the inclusions differs from the main material. The white lines could be quartz and the red coloured lines could be an indication for ferrous minerals. Another characteristic of the stone are small, longitudinal holes in the otherwise homogenous matrix, which can be mistakes for cracks. However, they are immanent in the rock and have no damage potential.

Fig. 1: Rock of Mountain, nearby the Water Temple

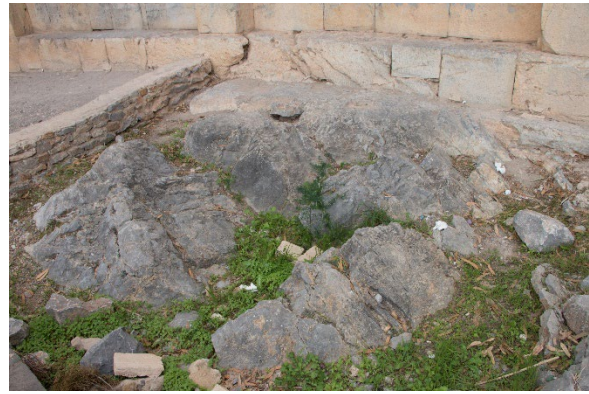
Fig. 2: Rock of Mountain, inside the Water Temple, West of the Cella

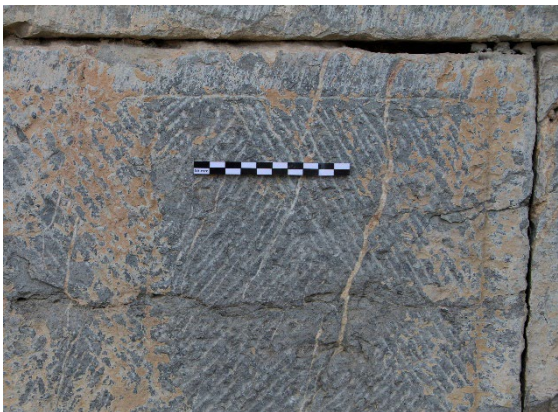
The surface processing of the limestone blocks is particularly noteworthy. Geometric patterns were created with fine decorative lines, using most probably pointed chisels (Fig. 5). In the interior and partially on the exterior walls of the cella, periodic holes and remains of a backfilling mortar can be observed in the ashlar masonry (Fig. 7). These findings can indicate at least a partial facing of the masonry with stone slabs (possibly marble). The light pinkish backfilling mortar can be interpreted as hydraulic lime mortar with various fine grained aggregates, including also ceramic materials.

Fig. 5: Stonemasonry processing of gray limestone, fine geometrical lines, Water Temple

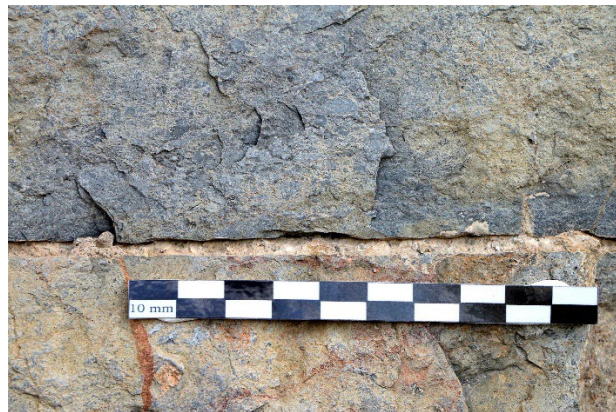
With an exceedingly thin joint pattern, the masonry should probably appear as dry wall. Nevertheless, there are a large number of mortar remains from what was most likely the original mortar bed of the ashlar masonry. The mortar has a white matrix with aggregates of different stone fragments. It is a lime-bound system, possibly with hydraulic properties (Fig. 6).

Fig. 6: Joint mortar of ashlar masonry, Water Temple

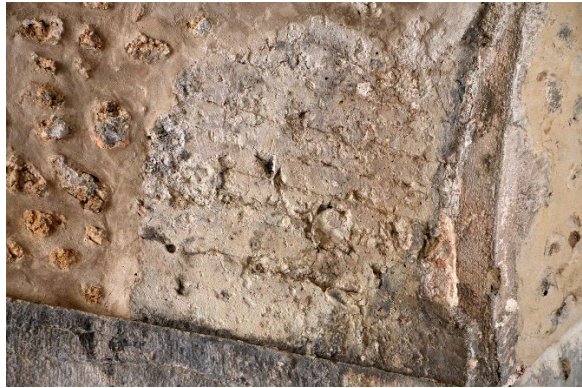
Due to a major restoration phase, covering nearly the entire joint inventory of the masonry with restoration mortar (see below) no statement about the original mortar of this type of masonry can be provided. Additionally, the great height of this type of inventory, without the possibility of close observation, allows only a superficial inspection. The original design of the visible surface of this masonry is only preserved in remains. The entire tufa masonry was probably covered with a layer of plaster (Fig. 10). The fine plaster was decoratively designed in sections (Fig. 11).

Fig. 10: Residues of plaster, vault zone, interior cella, Water Temple

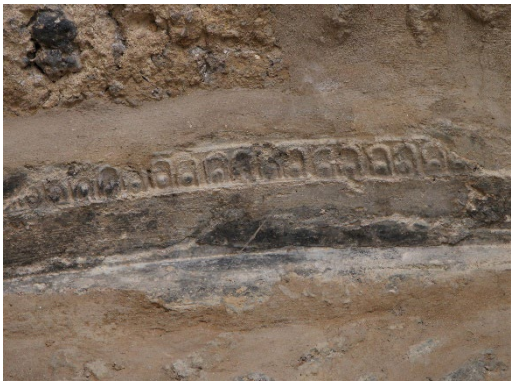
Fig. 11: Residues of decorative plaster, vault zone interior cella, Water Temple

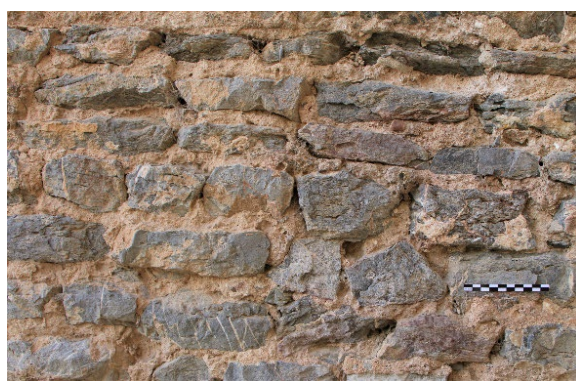
The eastern and the western wall of the cella show another masonry typ (Fig. 12). It was designed in the form of rubble stone masonry with a wide joint pattern. The stones were arranged in layers and partly brought into a rather rectangular shape. The masonry stone is mainly made of the nearby gray limestone same as the big ashlar masonry. The original mortar is hardly visible any more, since most of it is covered with modern restoration mortar. Nevertheless, in some areas the original mortar is visible, which consist of an orange matrix with aggregates of various stone fragments. The mortar has low strength and is lime-bound with probably hydraulic properties.

Fig. 12: Rubble stone masonry, cella wall, Water Temple

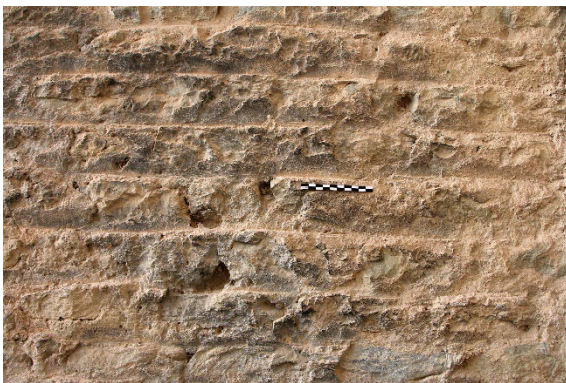
In the rain protected areas of the exterior rubble stone masonry of the cella walls, a joint coating has been preserved in sections, as well as a few remains of wall plaster (Fig. 13).

Fig. 13: Joint coating, cella wall, Water Temple

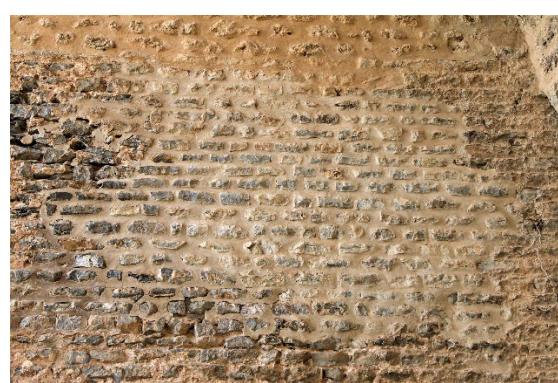
were closed in the last 47 years. The new masonry blocks were adapted to the original masonry in material and shape (Fig. 14). The supplemented areas in the rubble stone masonry of the cella were made of a slightly different stone. This has a lighter colour and also a more rectangular shape. Thus, restored and original wall sections can be distinguished via close observation. In the vault zone, no exact statement can be made due to the superficial examination from the ground. Additionally, the joints in this rubble stone walls of the cella walls and the vault zone were closed with at least two different restoration mortars (Fig. 15). All restoration mortars can be interpreted as fine-grained hydraulic lime mortar with probably cement added as binding agent.

Fig. 14: Restoration interventions, new masonry, cella wall, Water Temple

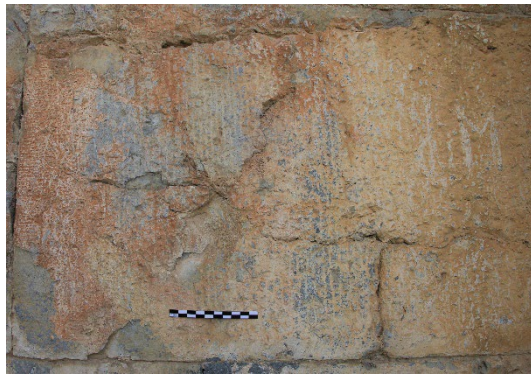
The first type of crust to be observed has an orange colour and is very similar to the oxalate patina found on ancient buildings throughout the Mediterranean region (Fig. 16). It is distributed in large areas in the east and west wing as well as in the interior and exterior space of the ashlar masonry. There is no potential for damage originating from this crust in the case of this object. On the contrary, the thin layer acts as protection layer for the substance underneath.

Fig. 15: Restoration interventions, restoration mortar, vault zone, Water Temple
 Fig. 16: Orange crust, ashlar masonry, wing, Water Temple

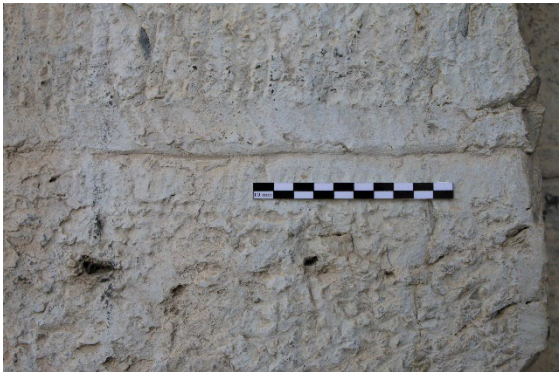
Furthermore, in large areas in the east and west wing as well as in the interior and exterior of the ashlar masonry of the cella white deposits on the vertical stone surface can be observed (Fig. 17). This very soft and calcareous crust can be found below the restored tufa areas, increasingly in rain-protected areas. The origin of the deposit is ambiguous; it might be a leached binding agent (lime) from the restoration mortar above.

Fig. 17: White crust / deposit, ashlar masonry, wing, Water Temple
 Fig. 18: Black deposit / crust, cella wall exterior, Water Temple

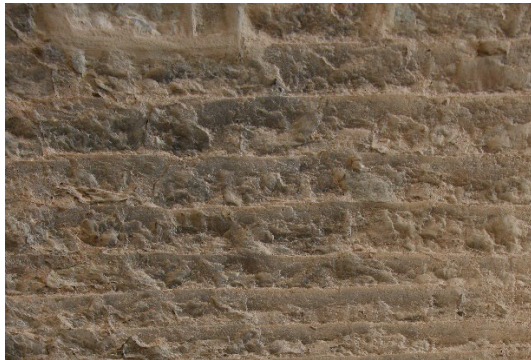
The last type of crust was found on the two outside rubble walls of the cella in the rain protected area along the south corners. The original joint coating has been preserved in this area. On top of that inventory a partially black crust as superficial layer is to be observed (Fig. 18) This could be soiling or gypsum crust. No damage potential can be observed from this crust either.

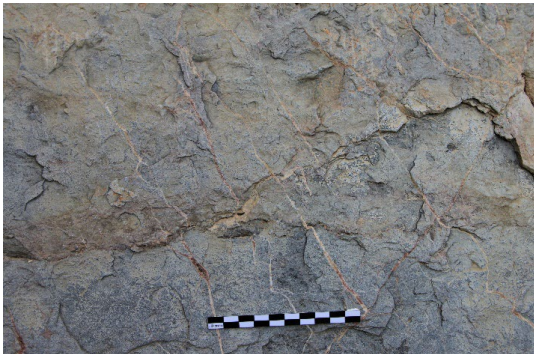
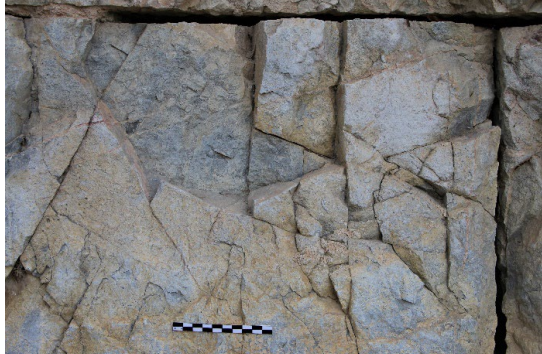
Fig. 19: Scaling, ashlar masonry, wing, Water Temple
 Fig. 20: Fragmentation, ashlar masonry, wing, Water Temple

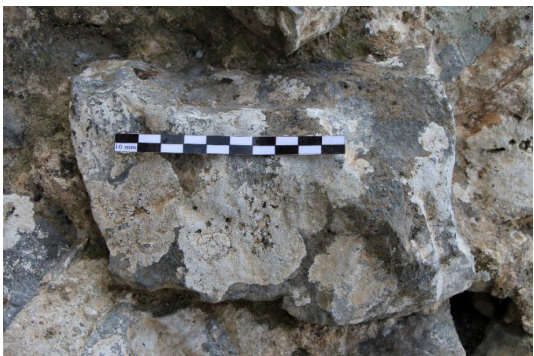
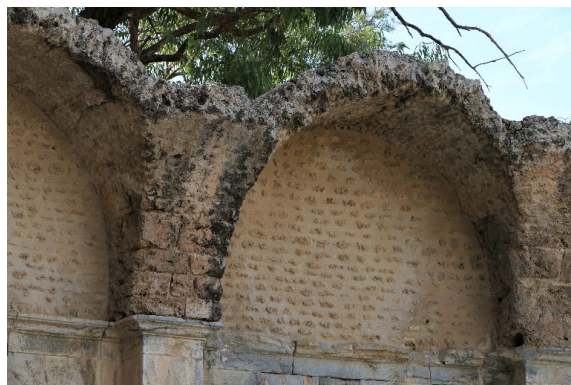
Fig. 21: Lichen, Water Temple
 Fig. 22: Black biofilm, vault zone, Water Temple

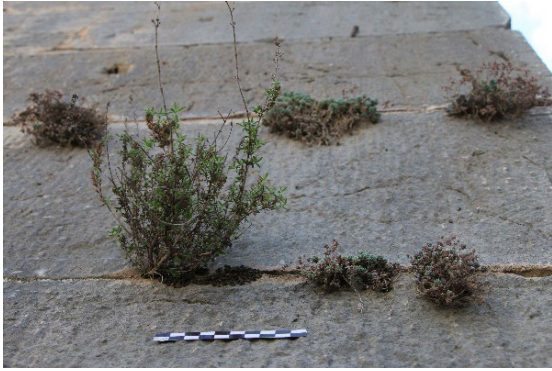
Fig. 23: Plants, ashlar masonry, cella exterior, Water Temple

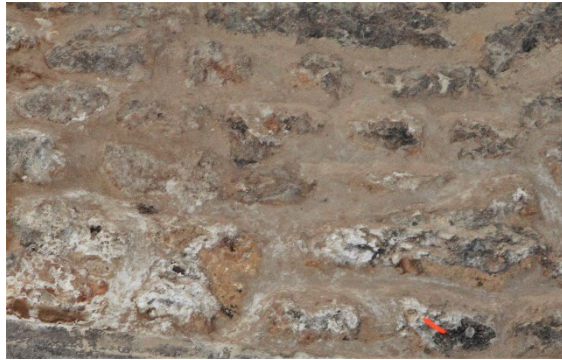
Fig. 24: Salt efflorescence, rubble stone wall, vault zone, interior cella, Water Temple

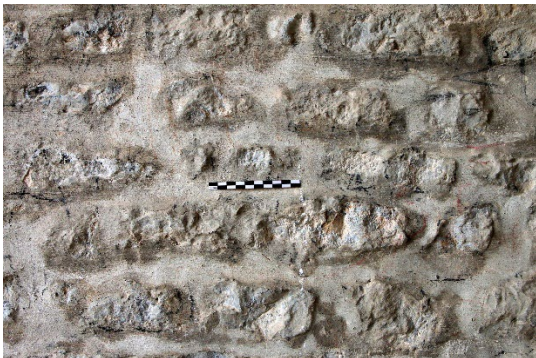
Fig. 25: Damp spots, possibly due to salts presence, rubble stone wall, cella interior, Water Temple

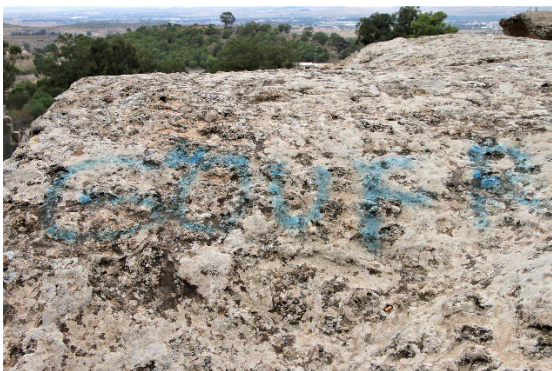
Fig. 29: Graffiti, roof cella exterior, Water Temple

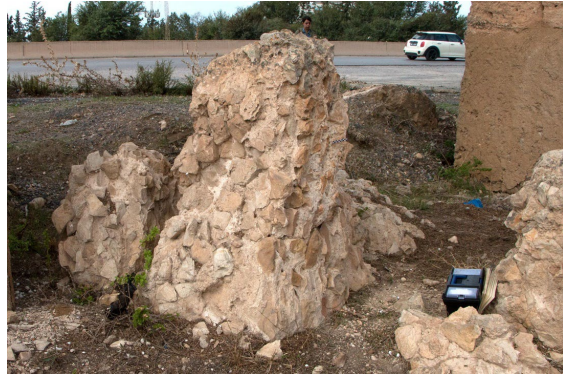
Fig. 44: Collapsed fragment of roman arch zone, opus caementicium core, Aqueduct

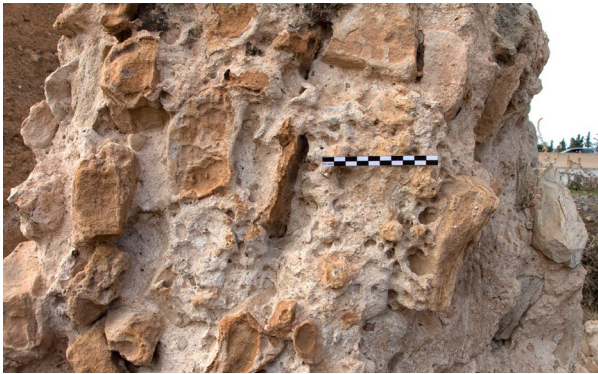
Fig. 45: Detail opus caementicium core, collapsed fragment, Aqueduct

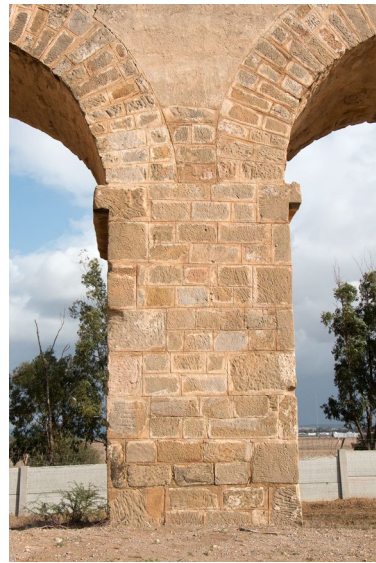
Fig. 46: Restoration intervention, sand stone masonry with so-called joint lines, Aqueduct

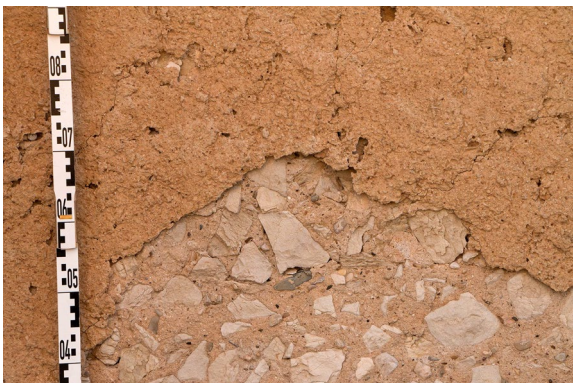
Fig. 47: Restoration intervention base zone of rammed-earth inventory, brown plaster and underneath restoration mortar, Aqueduct

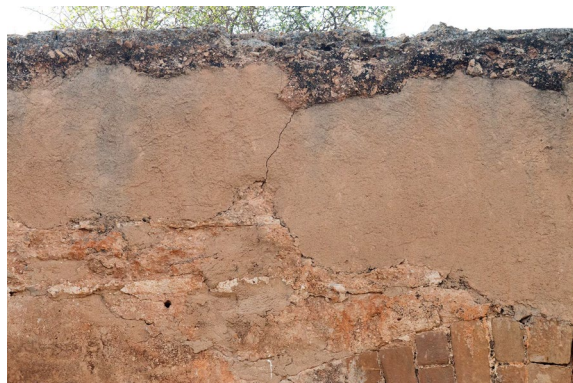
Fig. 48: Restoration intervention in rammed-earth inventory, arch and specus zone, Aqueduct

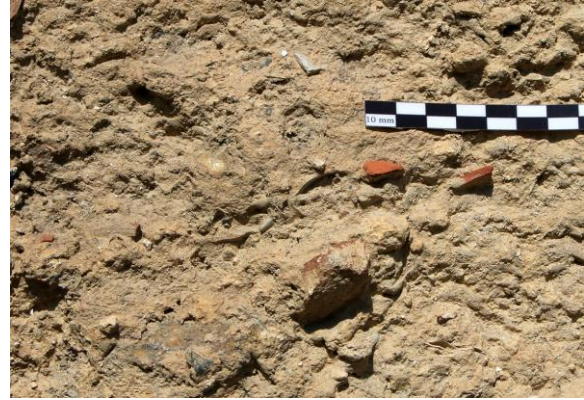
A very distinctive material was detected on the wall surface of the spandrels above P 27 and 28. On the surface of the opus caementitium core one can observe a mortar-like layer with large ceramic fragments inside (Fig. 8). Whether this is an additional mortar layer or subsequently consolidated cultural debris can hopefully be determined by the examination of the sample ZAQ_CAR_3⁸ taken from this material.

Fig. 8: "mortar with ceramic fragments"

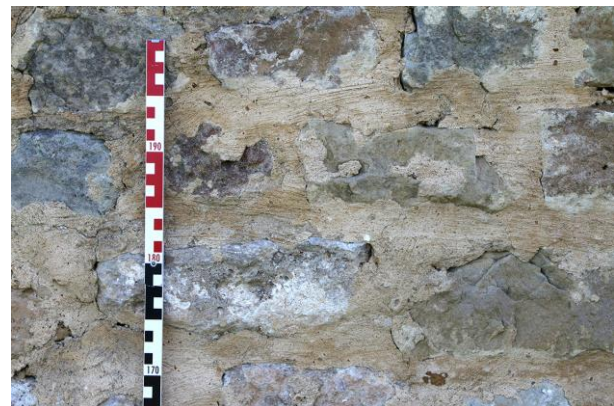
The restoration and reconstruction of the south side of the monument have a slightly different appearance (Fig. 13). In the spandrels above the pillars, the original structures are still visible in contrast to the north side. On this side it was decided, to not fully reconstruct the shape of the monument, but always only the fields, starting with F 26-27. This means that the vault was reconstructed as well as the areas of the wall above the fields until the specus level. The original construction is preserved in the spandrel of P 26, 27 and 28. One can notice that there are at least two recessed edges / borders in spandrels and arches. These were tried to imitate in the reconstructed areas. The accuracy of these reconstructed areas cannot be ascertained in parts. The execution and materials used for the restoration and reconstruction of the south side can be described as coherent with the materials from the north side. The only noticeable difference is that the joints are slightly below the level of the stones. Either this has already been executed or the joints are already slightly weathered back on this side.

Fig. 13: restoration / reconstruction phase, reconstruction of the vaults south side

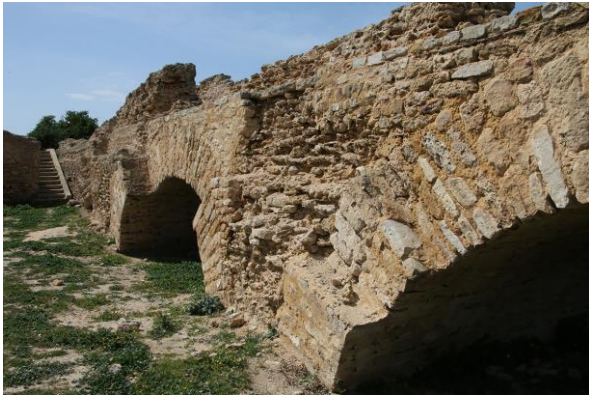
The underside of the vault from F 26 to 27 was also reconstructed. Here you can see the wooden formwork of the construction of the vault very well pressed into the mortar. The materials, stones and mortar, are presumably the same as on the reconstruction of the north and south sides (Fig. 14).

Fig. 14: restoration / reconstruction phase, reconstruction underside vault

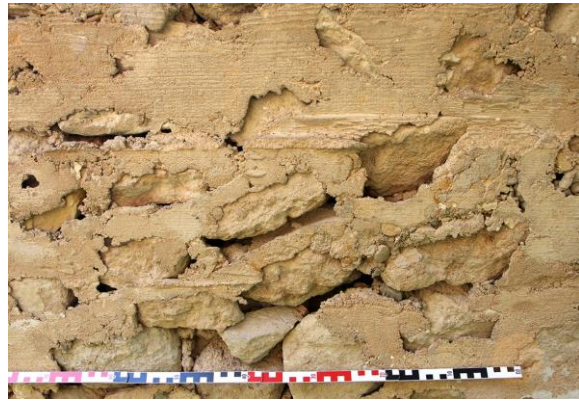
The now described measures were graphically documented in the mapping with the key modern restoration type I. On the north side, deviating reconstruction material was noted at one location. Here, hollow bricks and cement mortar were used (Fig. 15). The location of this intervention is shown in the mapping with restoration type II.

Fig. 15: restoration / reconstruction phase, restoration type II

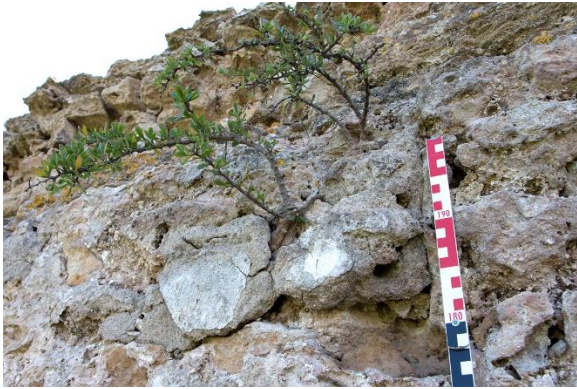
Occasionally also plants are to be observed in the examined area. These are increasingly attracted by weak areas, especially joints, cavities and cracks, to grow. Root pressure can cause cracks in the structure and hence can lead to damage or loss of material (Fig. 18).

Fig. 18: plants

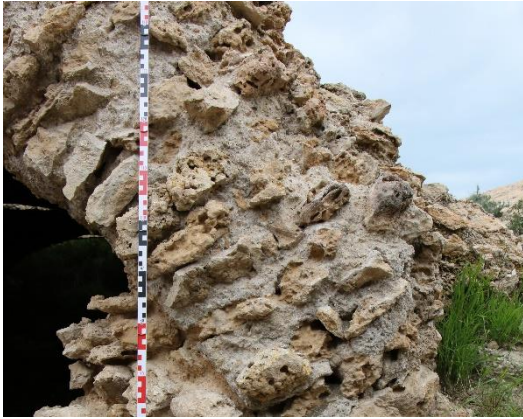
Fig. 24: vault masonry, cisterns

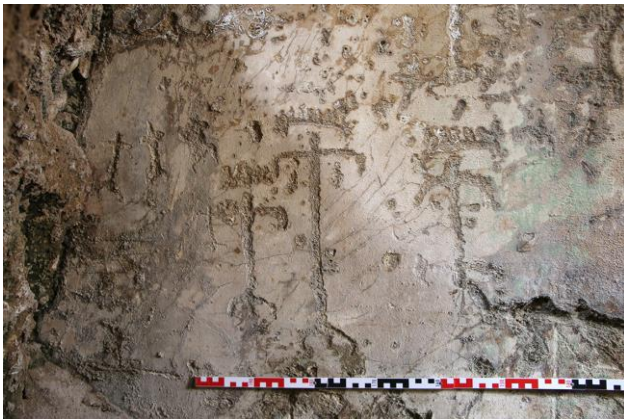
Fig. 38: plaster in the sondages interior with scratchings, cisterns
